Characterization of mineral building materials from the Fortress of Basthovë, Albania

Farkas Pintér, Marija Milchin and Gabriela Krist

3rd Heritage Science Austria Meeting, 23rd September 2022, Akademie der bildenden Künste Wien

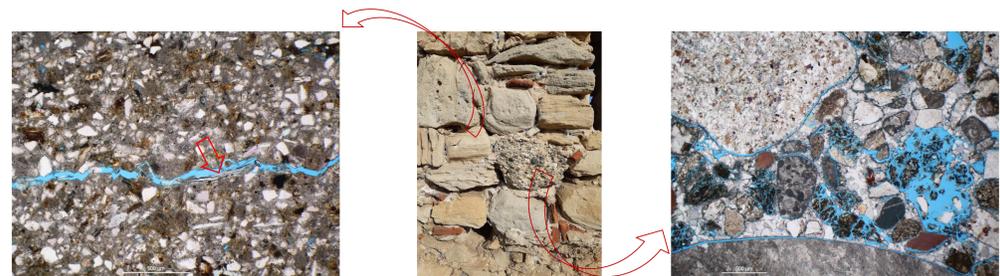
The majority of stone blocks belong to clastic sedimentary rocks which include a series of fine-grained sandstones to conglomerates (Fig. 2 and 3). The clasts are mostly of silicate (i.e. quartz, mica, chert, serpentinite, granite, etc.), ancillary of carbonate nature (i.e. limestone) cemented with fine to coarse-grained calcite (Fig. 3). Additionally, a few dense limestone types and processed white marble, the latter can be considered as spolia, could be identified. Although most of the stone blocks are in good state of preservation, problems occurred in zones where humidity caused, along with the dense joint mortars and/or due to the natural bedding of the stone, extended coving and cavities (Fig. 2). Furthermore, the vicinity of the sea (i.e. wind-driven salts) in combination with strong winds plays also a role in the deterioration processes. Finally, mineral composition, such as the presence of mica and the detachment between altered mineral clasts and the carbonate cement accelerated the above-mentioned processes (Fig. 3).

Fig. 2 Coving of sandstone blocks due to dense joint mortars and the influence of moisture

Based on the results of the laboratory analyses a mortar recipe was elaborated for re-pointing of the joints. The selected binder was a natural hydraulic lime (NHL 3.5) mixed with a local fluvial sand (0-2 mm) using a binder-to-aggregate ratio of 1:3 (by volume). In order to test the pointing mortar, a trial surface was prepared on the southern face of the NE-wall (Fig. 7). As a first step damaged and/or inappropriate mortars were removed and the joints were cleaned. Prior to the application of the mortar the zones to be re-pointed were brushed with a slurry produced from the same, but water-diluted mortar. The re-pointed surfaces were kept moist for a minimum of 16 hours by covering them with wet textiles and plastic foils before their surfaces could be scraped back in order to achieve the final form and overall appearance (Fig. 7). Finally, the joints were continuously kept moist to achieve an optimal strength development.

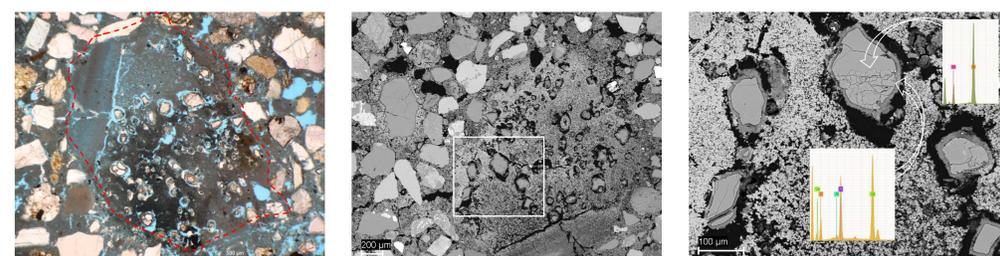
The mortars were produced from a sand of fluvial origin and an air lime binder with a certain hydraulic character. The observed hydraulic binder portions and burnt residues of the original raw material, such as lime lumps containing reacted silica grains and other binder-related inclusions exhibiting diffuse hydration rims, show similarity to natural hydraulic lime binders (Fig. 4 and 5). Therefore, the results suggest that the carbonate raw material used for the mortar naturally contained variable amounts of silica (e.g. quartz) and aluminates such as mica, feldspar and eventually also clay minerals. During the firing process these mineral components formed reactive Ca-silicate and Ca-aluminate phases and became partly hydrated during the slaking process (Fig. 5). The source of raw material might be related to the silty to sandy carbonate rock formations to be found in the vicinity of the castle. Additionally, large lime lumps (Fig. 4) suggest that the mortar mixes were prepared by using the so-called dry-slaking technique. Finally, infiltrating moisture and subsequent leaching left their traces back on the binders provoking a very heterogeneous matrix made up of an impure silica gel and calcium carbonate (Fig. 4). The aggregates show a very similar mineralogical properties to that of the local sediments and thus it is assumed that the same fluvial sand was taken from the nearby river and/or from an alluvial terrace. GSD varies between 0.05 and 1 mm with a clear dominance of the fractions between 0.2 and 0.4 mm in all samples (Fig. 4). The determined binder-to-aggregate ratios vary between 1 to 2.5 and 1 to 4. The mortar surfaces are mostly covered with secondary calcite crusts. In a few samples a calcium phosphate layer (Fig. 6) and gypsum crusts were detected. The presence of calcium phosphate can be explained by infiltrating PO_4^{3-} ions originating probably from accumulated guano on the roof terrace. The gypsum was presumably formed due to the reaction between the carbonate components of the original material and sulphate ions washed out from Portland cement-based mortars used during the reconstruction works in the 20th century.

Fig. 4 Left: large lime lumps (brown) in the porous mortar binder (thin section, PPL); center: glassy and Ca-silicate-bearing binder-related inclusion (thin section, PPL); right: hydrated and decalcified binder-related inclusion in a heterogeneous mortar binder (SEM-BSD)
