Long term mineral poultices with clay mineral content for the application in microbial and heavily salt contaminated monuments

M. Ortbauer | B. Sipek | J. Tichy | G. Piñar | M. Waldherr | A. Graf

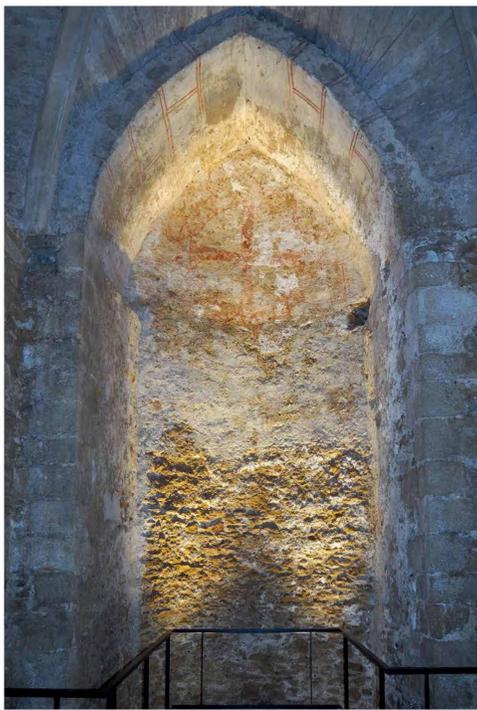
Eastern niche on the south side: The plaster is almost completely lost till the middle height of the niche due to the progressive salt damage. The painted consecration cross is barely recognisable.

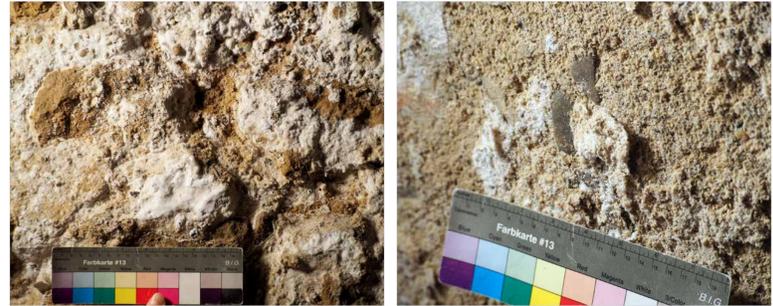
Characteristic salt damages in the Virgil Chapel: (left side) salt crusts on the surface, (right side) pressed-off salt crust.

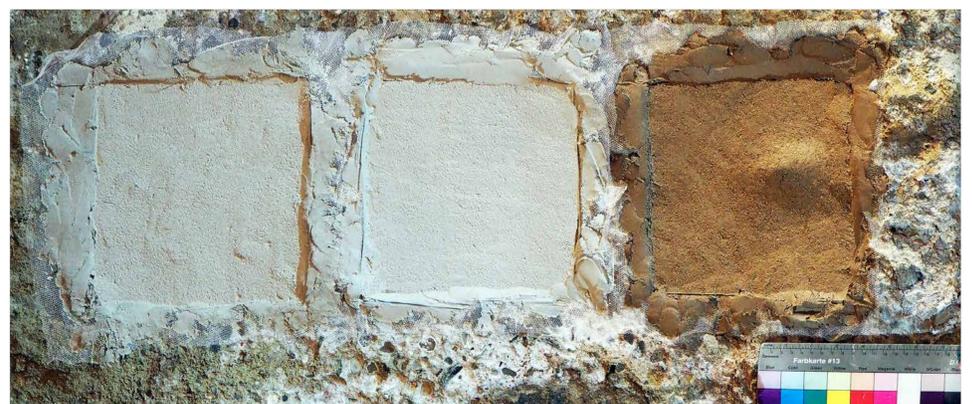
Test areas in the eastern niche of the south side: (from left to right) poultice with sepiolite, with kaolin and with vermiculite one week after application.

For the poultice mixtures, different layered silicates and aggregates in different mixing ratios were tested in a first phase under laboratory conditions. The three most promising poultices in terms of the predefined properties were then applied in the Virgil Chapel on the selected surface areas with visible microbial contamination, each on an area of 20 by 20 cm and a layer thickness of about 1 cm. Sampling of partial areas for analysis was carried out after 7, 30, 90 and 365 days.

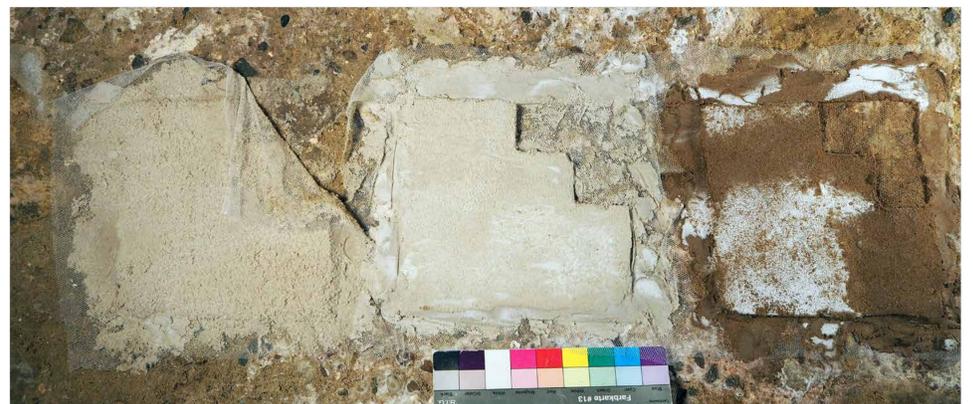
Test areas in the eastern niche of the south side: After three months, the poultices are differently damaged. The sepiolite containing poultice lost its surface. The kaolin and vermiculite containing poultices are still structurally intact.

First results indicate a great influence of the chosen clay mineral on the extraction of salts and the storage capacity of poultices. Likewise, after 3 months, a difference in the resistance of the three poultice mixtures to the salt load can already be seen, resulting from a combination of the salt load and the intrinsic properties of the poultices.

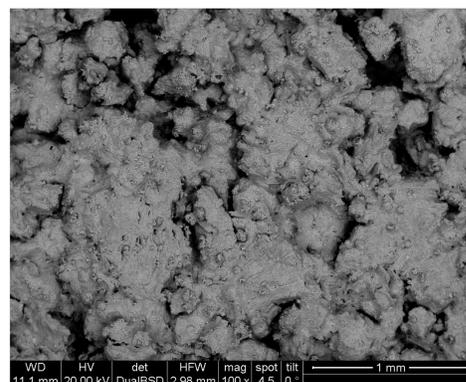
SEM images of poultices with vermiculite content in comparison with a kaolin containing poultice: (top left) The vermiculite containing poultice saturated with sodium chloride under laboratory conditions shows a surface almost completely covered with salt crystals. (top right) In the poultice with vermiculite content from the Virgil Chapel, taken after three months, the salt crystals have accumulated on the components and in the spaces between them. Despite the high salt load, the poultice in both cases can continue to absorb salts into the interstices.

(bottom right) In the kaolin containing poultice salt crystals (bright areas) are deposited sporadically, but without completely enveloping the components or filling their interstices. The poultice mixture only retains a small amount of salts compared to the poultice with vermiculite.

The poultices taken are examined for their properties and salt accumulation by means of mercury pressure porosimetry, X-ray diffraction (XRD), ion chromatography (IC), and in the scanning electron microscope (SEM).
