Characterization of mineral building materials from the Fortress of Basthovë, Albania

Farkas Pintér, Marija Milchin and Gabriela Krist

3rd Heritage Science Austria Meeting, 23rd September 2022, Akademie der bildenden Künste Wien

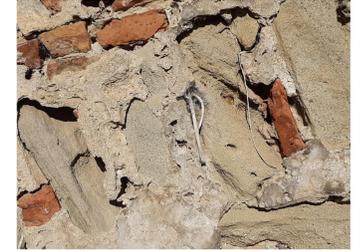
Fig. 1 The fortress of Basthovë during the conservation campaign in September 2022

Based on the results of the laboratory analyses a mortar recipe was elaborated for re-pointing of the joints. The selected binder was a natural hydraulic lime (NHL 3.5) mixed with a local fluvial sand (0-2 mm) using a binder-to-aggregate ratio of 1:3 (by volume). In order to test the pointing mortar, a trial surface was prepared on the southern face of the NE-wall (Fig. 7). As a first step damaged and/or inappropriate mortars were removed and the joints were cleaned. Prior to the application of the mortar the zones to be re-pointed were brushed with a slurry produced from the same, but water-diluted mortar. The re-pointed surfaces were kept moist for a minimum of 16 hours by covering them with wet textiles and plastic foils before their surfaces could be scraped back in order to achieve the final form and overall appearance (Fig. 7). Finally, the joints were continuously kept moist to achieve an optimal strength development.
